# **Black & White House Museum**

## **Timber-Frame Infill Panel Repair and Replacement Specification**

April 2019

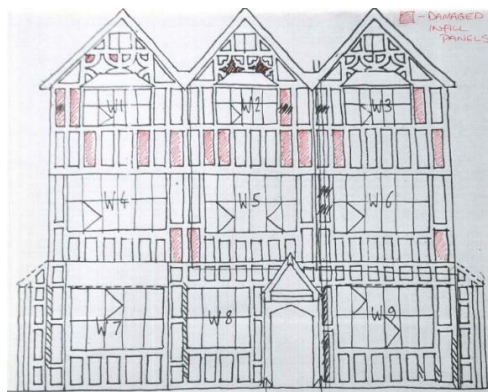
South Elevation

- 2.2 The eastern and southern elevations are the worst effected, with over 20 damaged panels on each façade.
- 2.3 The western elevation has a significantly lower rate of failure, 3 panels, and there appear to be no failures on the northern elevation.

- 2.4 The orientation of the building will have influenced where damaged has occurred as the eastern elevation gets the morning sun, and the southern elevation has prolonged exposure to the sun at the hottest times of the day, both situations resulting in increased levels of thermal expansion.

- 6.1 The following elevation drawings were part of the 1990 application, and have been used to highlight damaged panels.
- 6.2 Sections hatched in red ink signify a damaged or cracked panel.
