Condition Survey and Recommendation for Improvement Works

The Old House Museum, Hereford April 2021

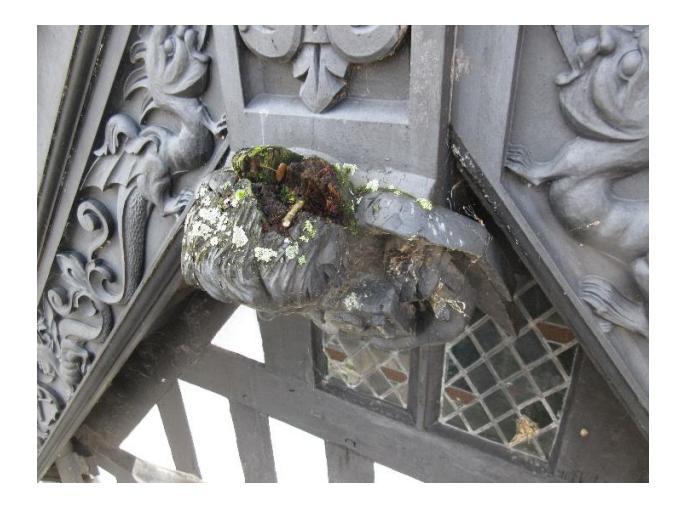
N3 centre pendant: back of carved head decayed; threaded stainless steel fixing bolt exposed.

- Repair 5no carved pendant characters adorning gable apex. Introduce discreet lead cover flashing over upper surfaces of all 8 pendants following repair and redecoration.

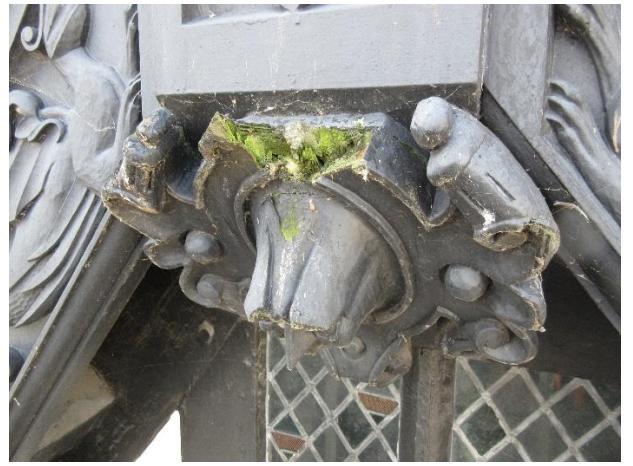
N3 west pendant: top section of surround missing; trapped moisture encouraging organic growth /further decay

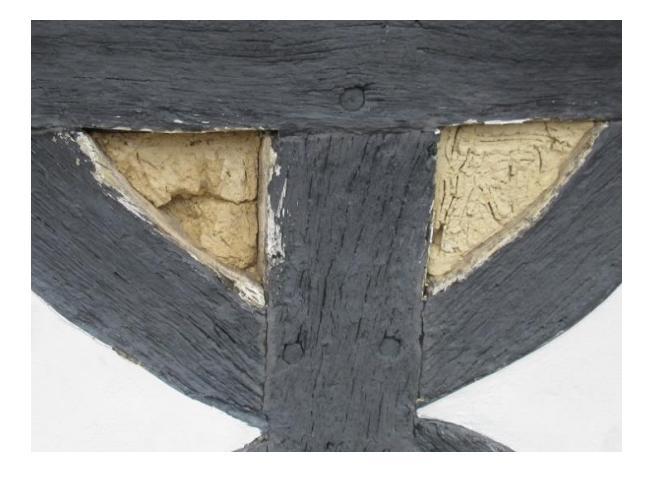
S3P4 & P5 infill panels: expanded metal lathing visible; adjacent areas loose

- Where defective panel is supported on modern woodwool slab or expanded metal lathing, assume complete replacement with new wattle and daub panel construction.

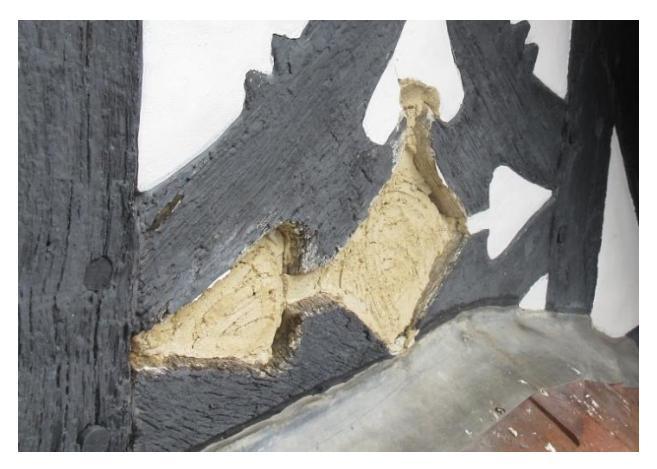
S3P11 infill panel: float coat failure; remaining scratch coat springy; adjacent areas loose.

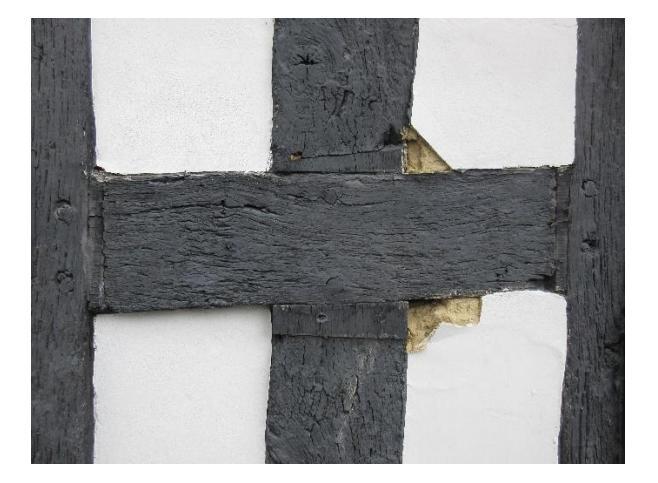
S2P3/4/11/12: loose, split small patch repairs to frame junctions.

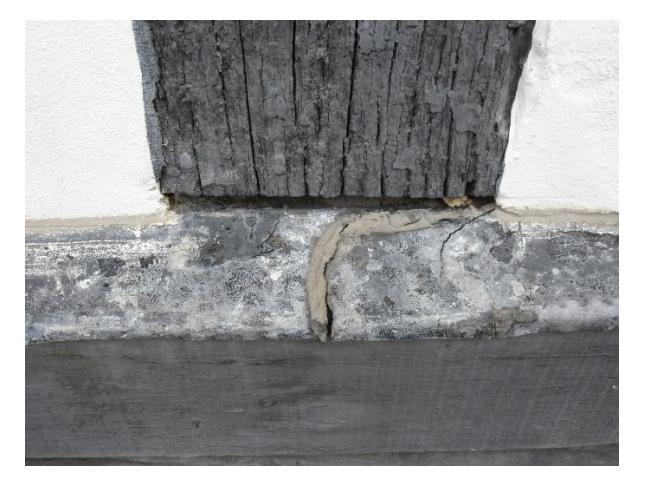
S2P8/9: studs stop short of refaced 2nd floor bressummer beam; overlong lead cover flashing split.

- 2.2.3.3. Overlong lead cover flashing to S elevation bressummer beam split in several places; new sections required refer to drawings.
- 2.2.3.4. Damaged cut plain tile over windows N2W8 and E2W1 renew.

- 2.4.3.1. Minor repairs to fixed leaded light windows in timber frames.
- 2.4.3.2. Renew isolated broken clay plain tiles to bay window roofs.
- 2.4.3.3. Repair/ renew sections of lead cover flashing to south elevation 2nd floor bressummer beam.
- 2.4.3.4. Remove sealant joint over lead cover flashing at top abutment of tiled roofs refer to specification for repair detail.

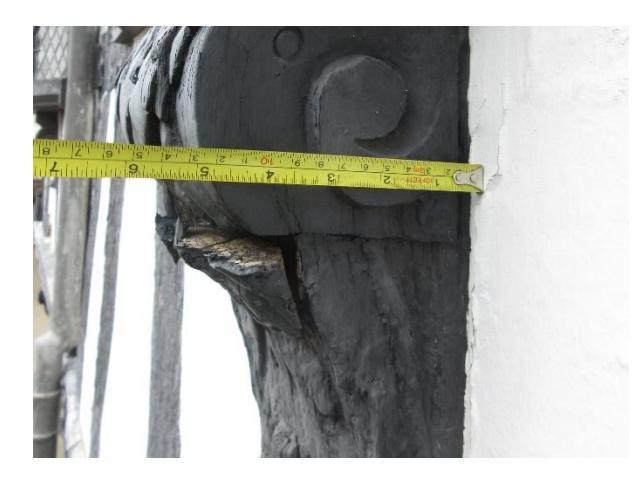
- 2.2.1.4. Carved acanthus leaf bracket below window S2W18 is opening up at junction with previous repair; refixing and minor repair needed.
- 2.2.1.5. Proud and missing oak pellets to previously repaired window sills on N & S elevations require reinstatement refer to drawings.

S2P20/21 bracket: refix loose acanthus leaf bracket detail below previous repair.

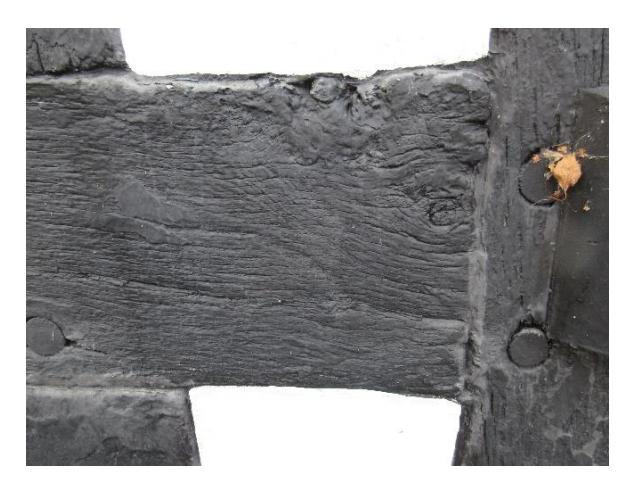
N2P2/6: modern sealant at frame junctions

- 2.2.1.6. Loose previous repair to sill below N2W11 needs refixing.
- 2.2.1.7. Loose previous repair/ split section of transom below S2W15 & W20 needs refixing.
- 2.2.1.8. Remove all modern gun-applied sealant at junctions, splits and shakes etc. prior to redecoration.

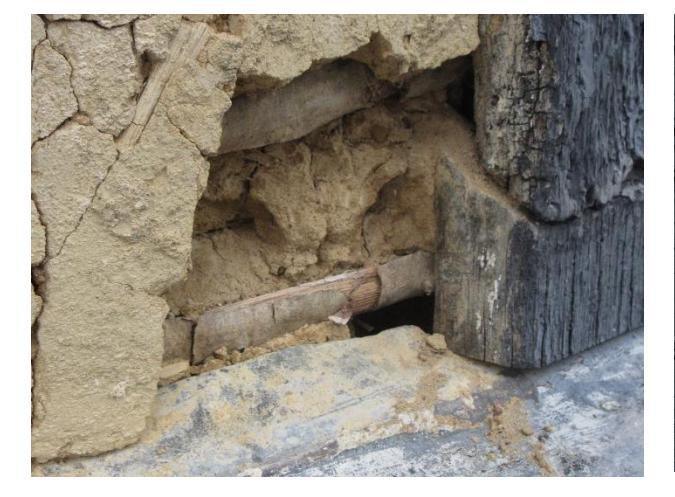
S2P5 infill panel: thin widely spaced wattles with bark still attached; no staves evident; face repair to base of stud.

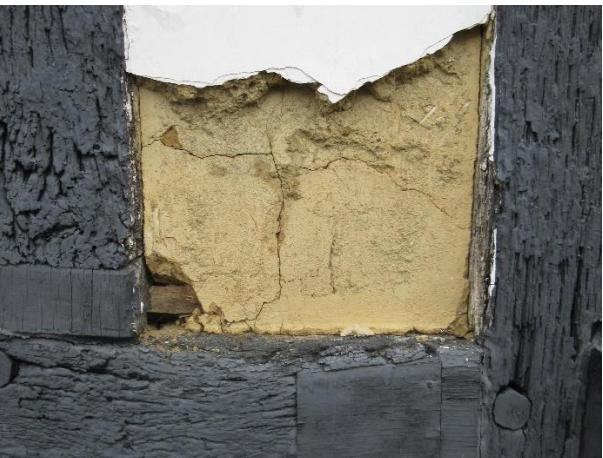
S2P2 infill panel: riven lath located into groove in stud; poor key has contributed to delamination and loss of float coat; numerous patch repairs to frame.

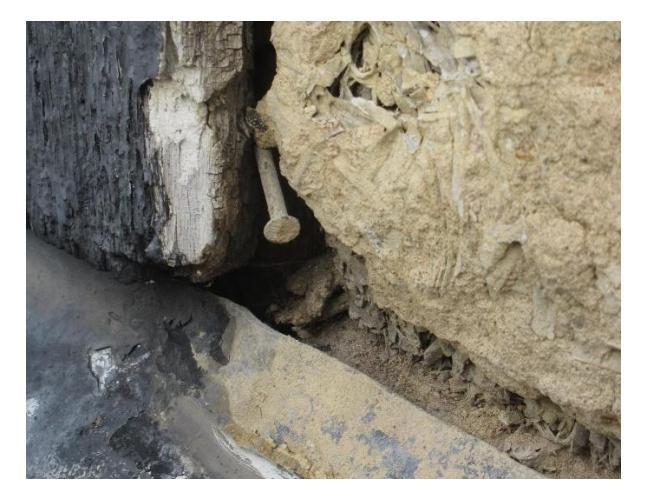
S2P23 infill panel: skew nailed woodwool slab fits poorly into frame.

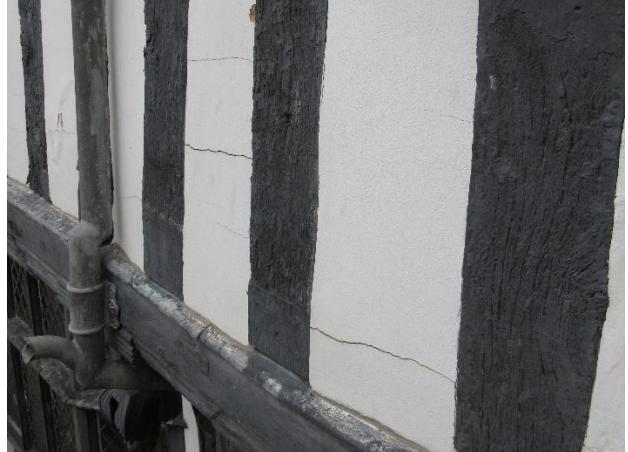
- 2.2.2.6. Horizontal, parallel cracks in render suggest movement or deflection possibly resulting from inadequate support or excessive thickness.
- 2.2.2.7. Delamination of paint finishes possibly caused by overpainting with modern coatings.

S2P18/19: parallel cracks in infill panels.

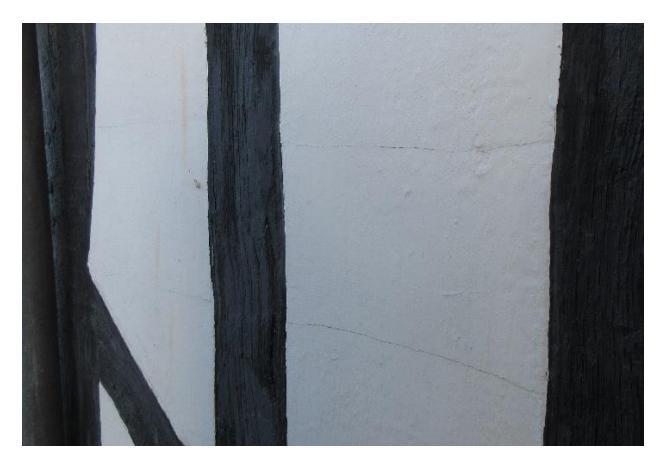
- 2.3.2.4. Delamination of paint finishes possibly caused by overpainting with modern coatings.
- 2.3.2.5. Horizontal, parallel cracks in render suggest movement or deflection perhaps resulting from inadequate support or excessive thickness.

E1P2/3: horizontal parallel cracks

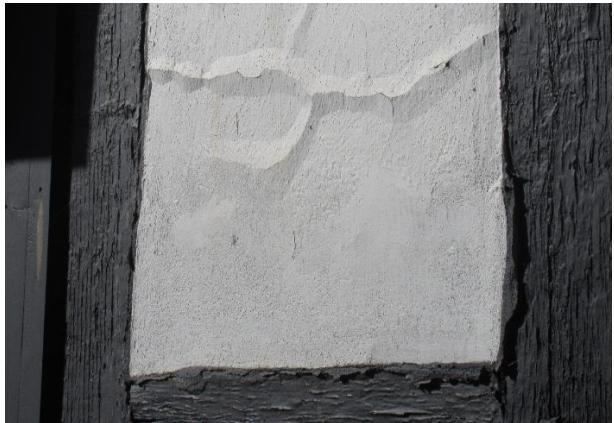
E1P5: delaminating paint finishes; render proud at bottom of panel

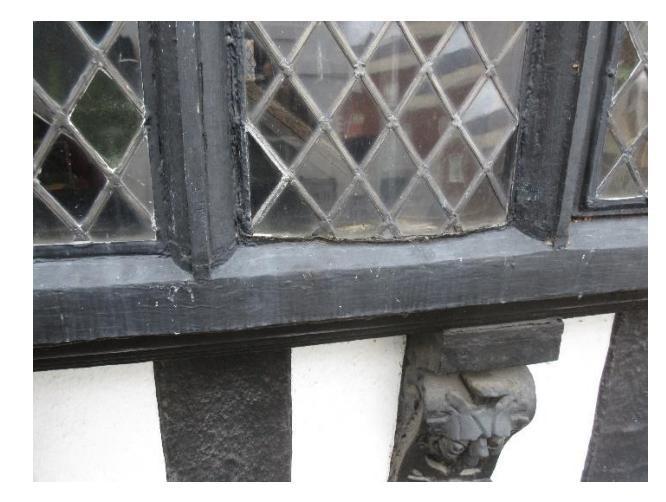
N1W10 window: sagging leaded light panel.

- 2.3.3.1. Window N1W10 leaded fixed lights sagging in frame dismantle, remove to workshop, clean and repair then reinstate in existing timber frame.
- 2.3.3.2. Broken quarry in window N1W13 renew in matching glass
- 2.3.3.3. Loose quarries in window S1W6 clean out and make good with waterproof glazing 'cement'.
- 2.3.3.4. Bird deterrent gel leaching into timber transoms and sills remove gel before redecoration.
- 2.3.3.5. Remove sealant joint to lead abutment flashing over pent roofs to ground floor refer to drawings.

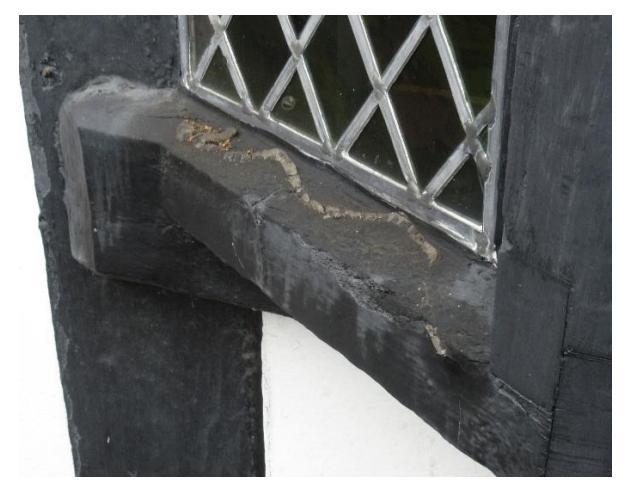
- 2.2.3.1. Occasional ferrous fixings to rainwater goods on S elevation corroding replace with non-ferrous.
- 2.2.3.2. Bird deterrent gel leaching into timber transoms and sills remove gel before redecoration.

N1W20 sill: bird deterrent gel leaching into timber.

- Remove leaching bird deterrent gel on transoms and sills before repair and redecoration.
 - Prepare and redecorate external timber with linseed oil paint.
