Outline ecological appraisal for the installation of fishing platforms on the River Wye (SAC)

Site NGR: SO5056739432

Date of survey: 03/02/2020

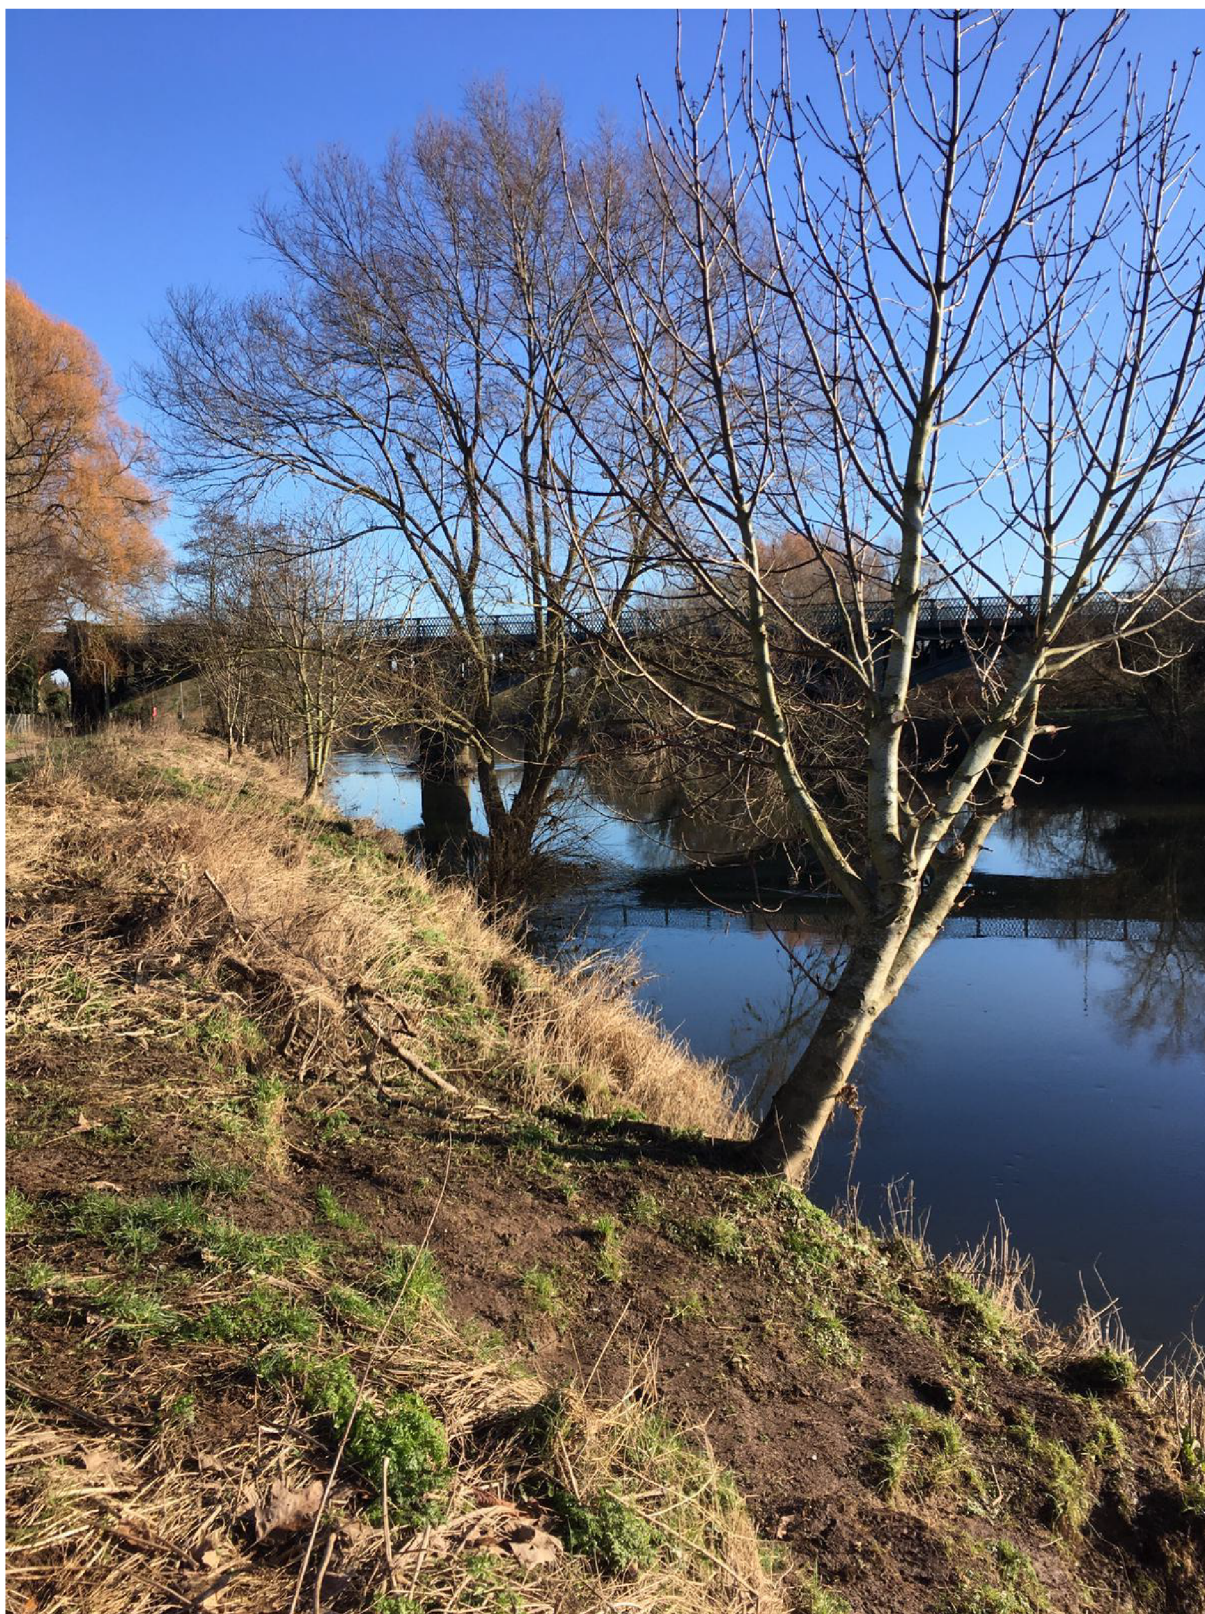
The banks of the Wye in this location has a sparse covering of trees including willow, alder, ash, oak and horse chestnut (see Picture 1). Much of the bank surrounding the fishing pegs was bare earth (see Picture 2), suffering erosion from footfall and steps being cut out of the banks to access the river. The bare earth is also likely caused by Himalayan balsam which grows here in abundance. Plants that were present by the fishing pegs included rye grass, dock, common hogweed, willow herb, reed canary grass and nettle. In between the fishing pegs were trees with a scrub layer comprised of bramble, ivy and self-set willow.

Picture 1- Typical bankside vegetation between fishing pegs.

The areas of scrub in-between the fishing platforms were some of the more interesting features in the area in terms of habitat potential for otter, bats, breeding birds and reptiles. These areas of scrub are not scheduled for removal. Any vegetation management required as part of the works should take place outside of the breeding bird season (March-August inclusive).

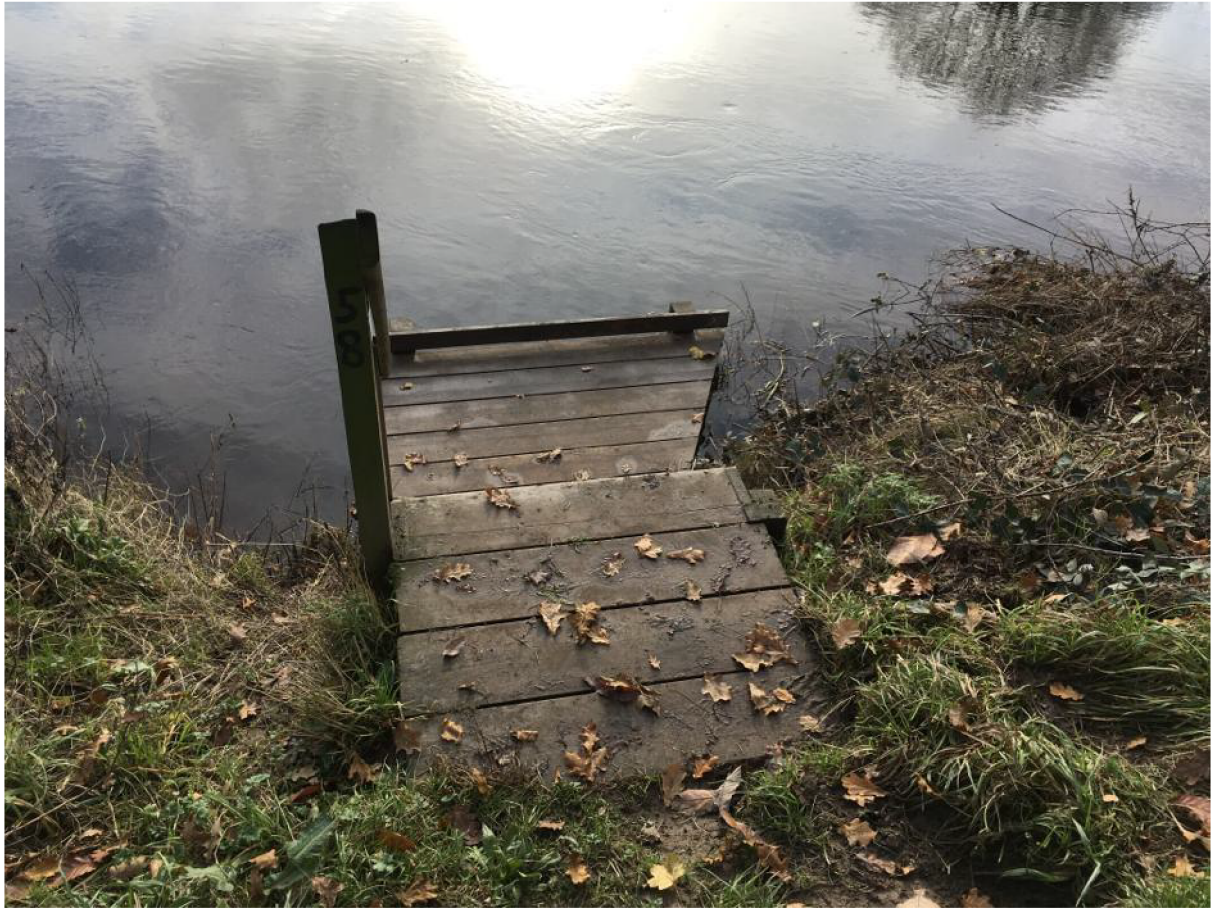
Picture 2- Example of a fishing platform previously installed on site.

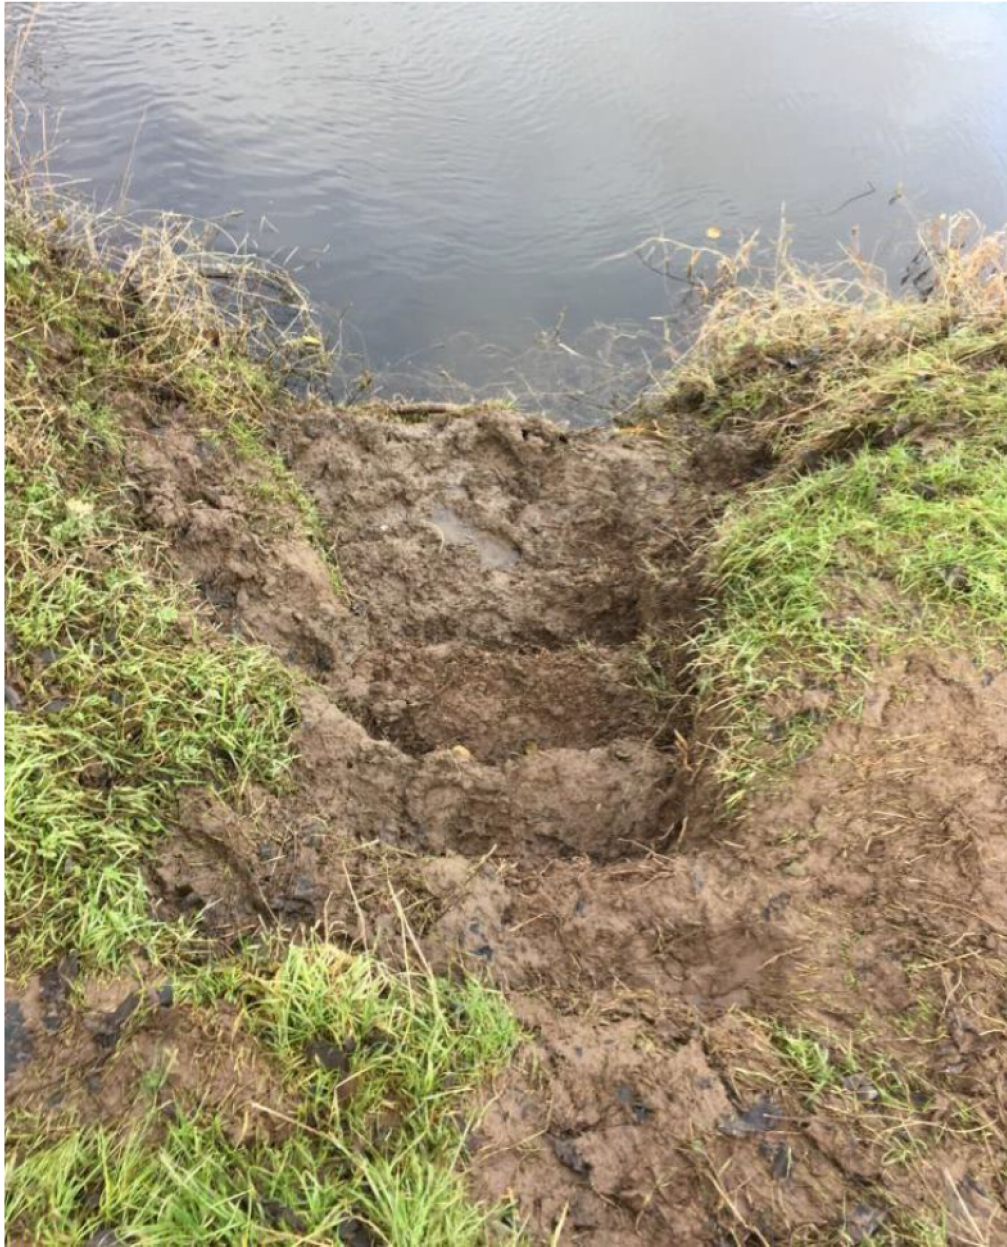
Picture 3- View of steps being cut into the river bank to access the river.

All works should aim to avoid pollution to the watercourse. Spill kits should be present on site and damage to the banks of the river avoided.
