# **Black & White House Museum**

## **Timber-Frame Infill Panel Repair and Replacement Specification**

April 2019

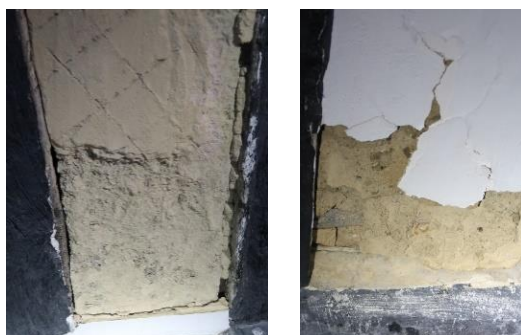
- 3.1 In 1990 the listed building consent application details the 4" infill area as having a 1" 2-coat lime plaster external face, a 2" wood wool substrate, and a 1" 3-coat lime plaster internal face.
- 3.2 The 1992 application details wattle & daub as the replacement material, with limewash as an external finish, and distemper for the internal finish.
- 3.3 Both specifications are present on the southern elevation, and both have failed, albeit they were undertaken nearly 30 years ago. As any new panels will be replacing modern ones there is no requirement to use one system over the other; the use of wood wool board would be the most practical solution.
